ANALYSIS OF THE CAUSES OF DECREASED LUBRICATING OIL PRESSURE IN THE TONASA LINES XII AIRCRAFT CARRIER ENGINE

Eko Nugroho Widjatmoko¹, P Marcello Lopulalan², Driaskoro Budi Sidharta³, Eko Prasetyo⁴

^{1,2,3,4}Politeknik Transportasi Sungai Danau dan Penyeberangan Palembang

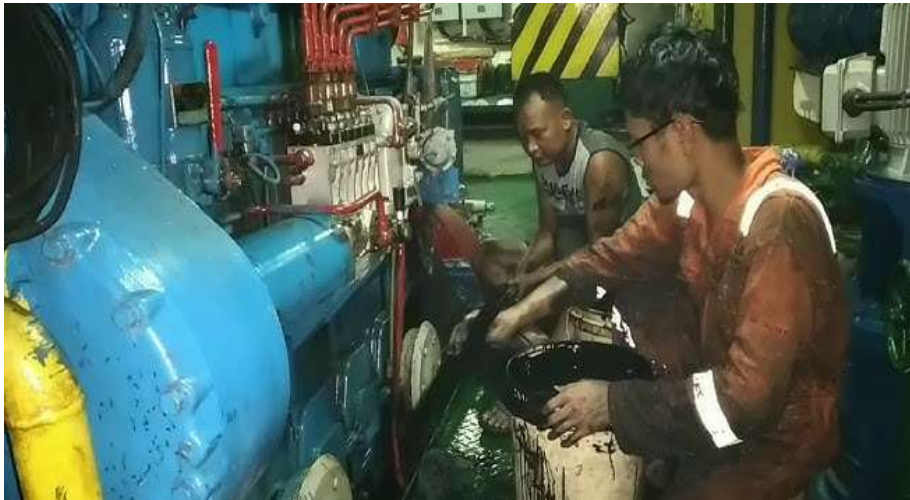
In addition to the above data, researchers also conducted interviews with machinists on duty to determine the cause of the drop in lubricating oil pressure. After conducting interviews, it was found that several factors caused the decline in lubricating oil technology. One of the most common factors was the dirty lubricating oil filter. The decrease in lubricating oil pressure increases exhaust gas temperature and a decrease in power from the main engine. Furthermore, handling this is to clean or replace the lubricating oil filter.

After conducting interviews, researchers made direct observations by following the replacement of lubricating oil fillters.

Figure 1. Lubricating Oil Filter Replacement in the main machine

evidenced by the data in Table 1. At the time of observation, determine the cause of the drop in lubricating oil pressure in KM. Tonasa Line XII found that the cause was a dirty lubricant filter.

After replacing the lubricating oil filter, data is retrieved at the same time interval as the data before it was replaced.

The data above shows that the lubricating oil pressure returns to normal at 3 kg / m², followed by the exhaust gas temperature that returns to normal, which is 250-252°C. This also affects the power (KW), which increases to 20 KW.

To deal with this, the machinist performs maintenance by replacing the lubricating oil filter with a new one. After being installed and checked again, the lubricating oil pressure returns to normal and is followed by the exhaust gas temperature, which drops to normal, and the power increases back to normal.
